SUBJECT Basement Shelter in Vilnius ;  
(description thereof;  
plan of shelter; sketches of  
filter system and entrance  
door)

ATOMIC SHELTER IN VILNYUS

Atomic Shelter in Vilnyus

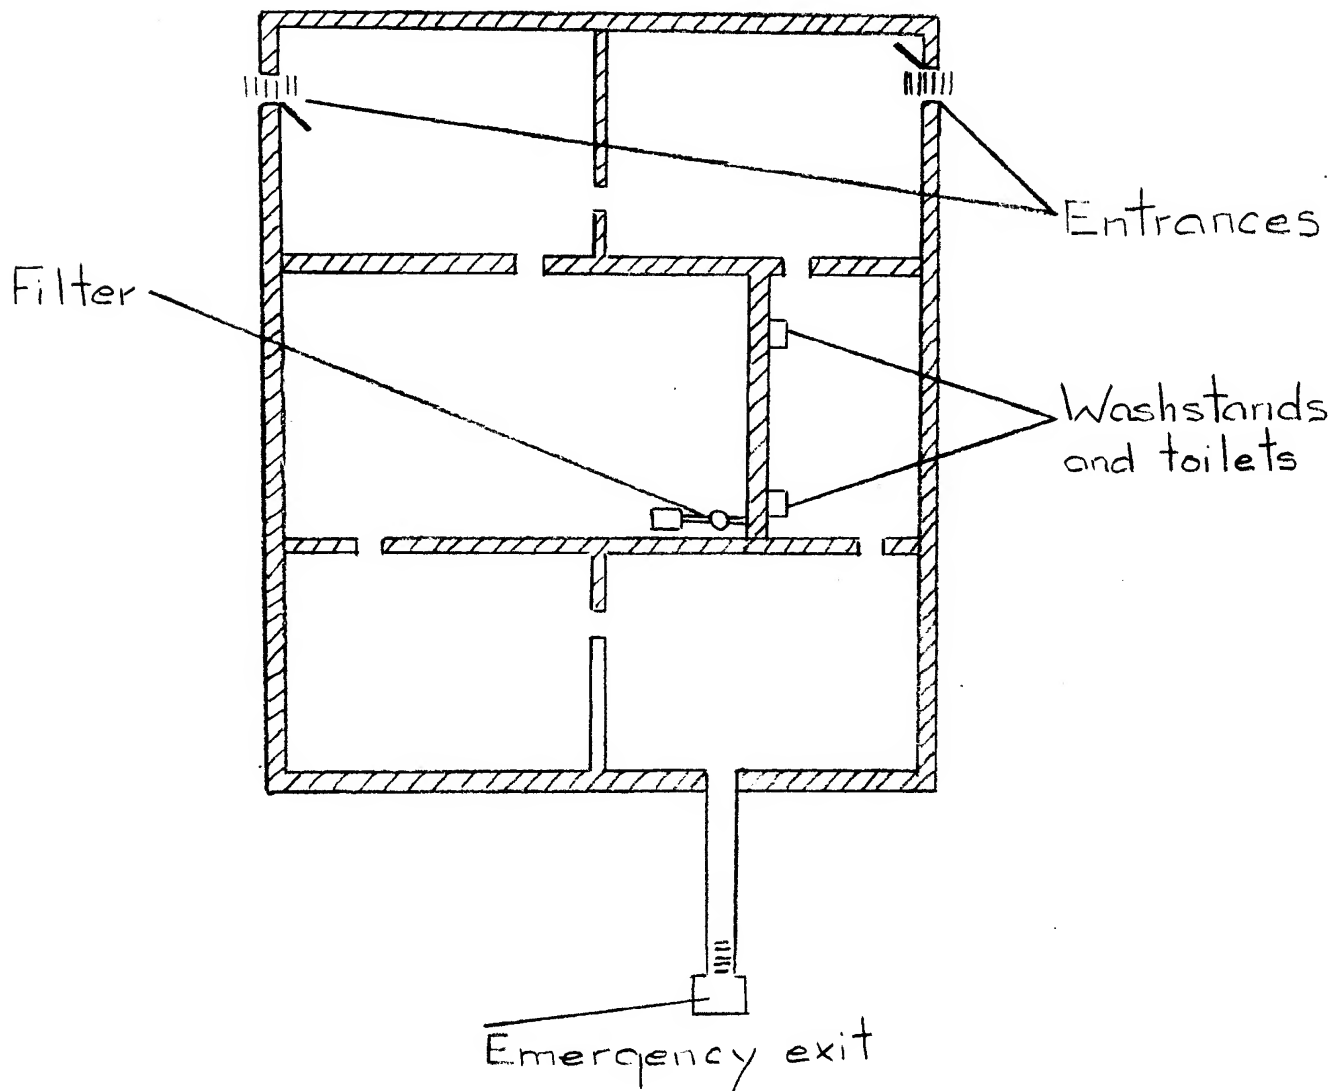
# Atomic Shelter in Vilnius (No. 1)

1. In general all new houses had shelters more or less like the one sketched in attachment No. 1.
2. The following is [ ] description of an atomic shelter in the basement of the building [ ] in Vilnyus. 50X1-HUM

Shelter: It occupied all of the basement. The ceiling and walls were of concrete. [ ] 50X1-HUM

Interior: It was divided into several rooms without passages. The dividing concrete partitions were about 25 centimeters thick. Some of the rooms communicated with others by means of doors. [ ] the two doors of a room did not face each other. Each room was for several families. There was a room with toilets and wash-stands. 50X1-HUM

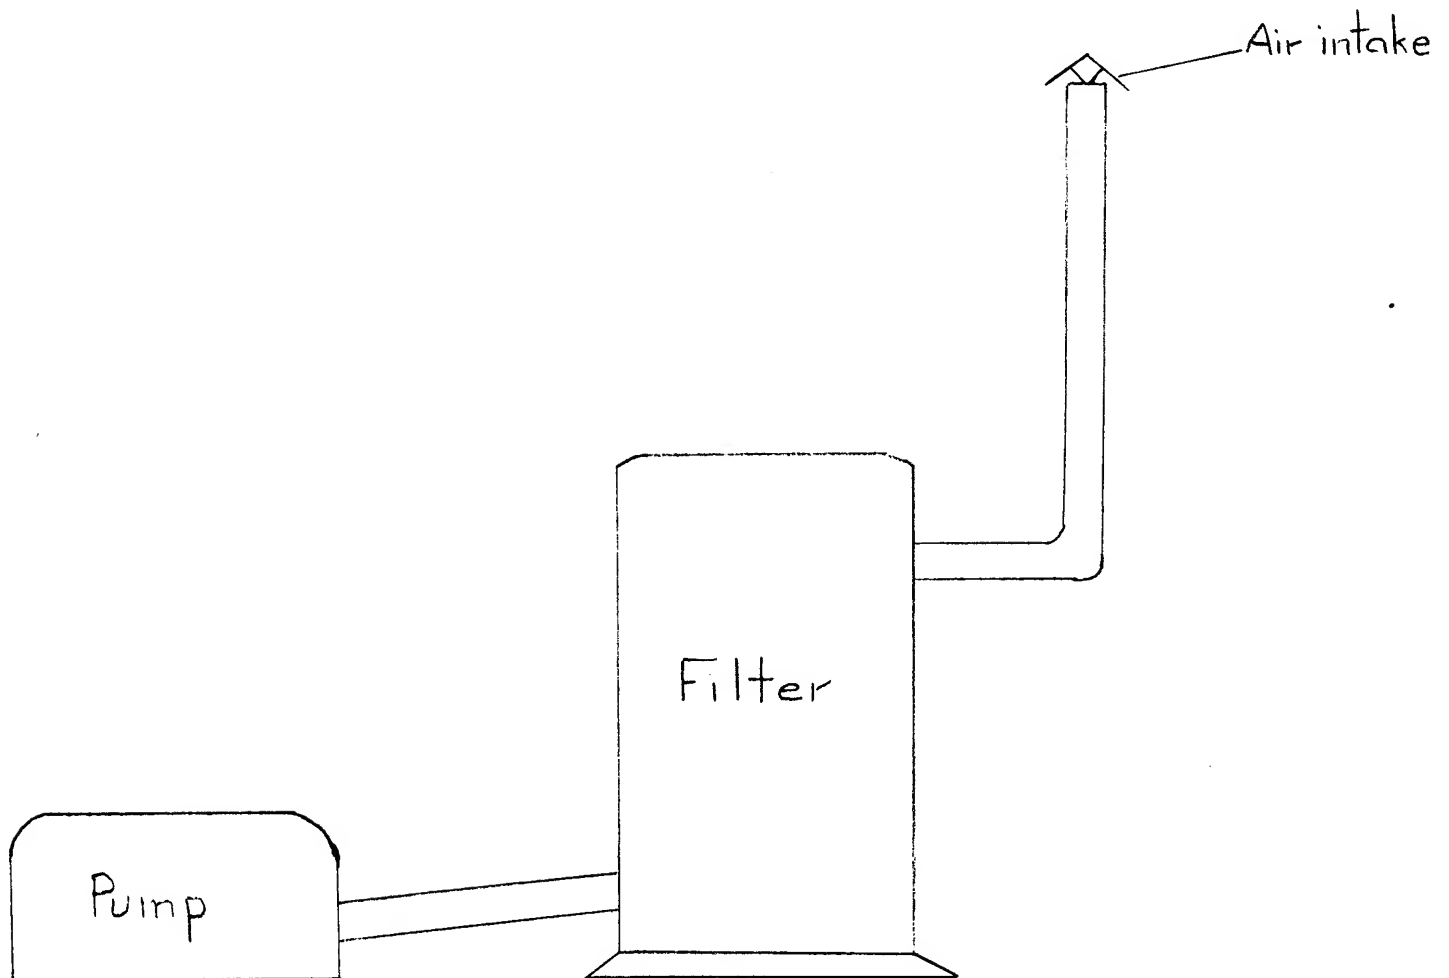
Air filter: (See attachment No. 2.) There was an air filter in the central room. The kind of substances contained in the air filter were unknown [ ] Next to it, there was an apparatus resembling a motor [ ] believed [ ] a pump for drawing air through the filter. 50X1-HUM

Filter for purifying radioactive air in an atomic  
shelter in the city of Vilnyus (Alt. No 2)

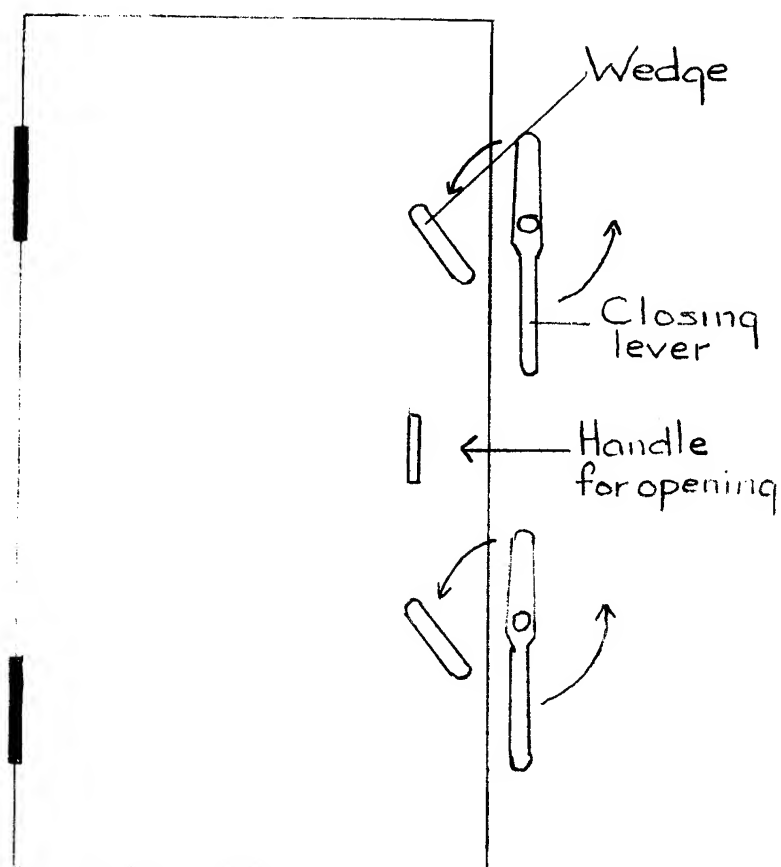
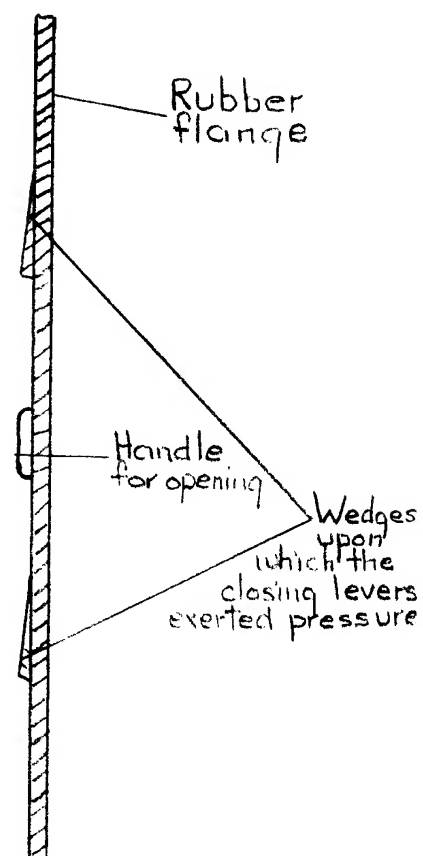
Doors: (See attachment No. 3.) The shelter had two entrances each with a stairway. The 2m x 0.85m doors were of ten millimeter thick steel with a smooth surface and a rubber flange around the edge which permitted airtight sealing. Two heavy hinges held the doors in place. Two closing levers attached to the wall lowered onto a kind of wedge welded to the door. The more the levers were lowered, the more tightly the door was closed.

Entrance doors of an atomic shelter in the city  
of Vilnyus (Att. No 3)
